DEPARTMENT OF TRANSPORTATION**DIVISION OF ENGINEERING SERVICES**

Contract #: 04-0120F4Cty: SF/ALA Rte: 80 PM: 13.2/13.9File #: 1.28**WELDING INSPECTION REPORT****Resident Engineer:** Casey, William**Address:** 333 Burma Road**City:** Oakland, CA 94607**Report No:** WIR-029911**Date Inspected:** 05-Aug-2013**Project Name:** SAS Superstructure**OSM Arrival Time:** 700**Prime Contractor:** American Bridge/Fluor Enterprises, a JV**OSM Departure Time:** 1730**Contractor:** American Bridge/Fluor Enterprises, a JV**Location:** Job Site**CWI Name:** Jesse Cayabyab**CWI Present:** Yes No**Inspected CWI report:** Yes No N/A**Rod Oven in Use:** Yes No N/A**Electrode to specification:** Yes No N/A**Weld Procedures Followed:** Yes No N/A**Qualified Welders:** Yes No N/A**Verified Joint Fit-up:** Yes No N/A**Approved Drawings:** Yes No N/A**Approved WPS:** Yes No N/A**Delayed / Cancelled:** Yes No N/A**Bridge No:** 34-0006**Component:** SAS OBG and Tower**Summary of Items Observed:**

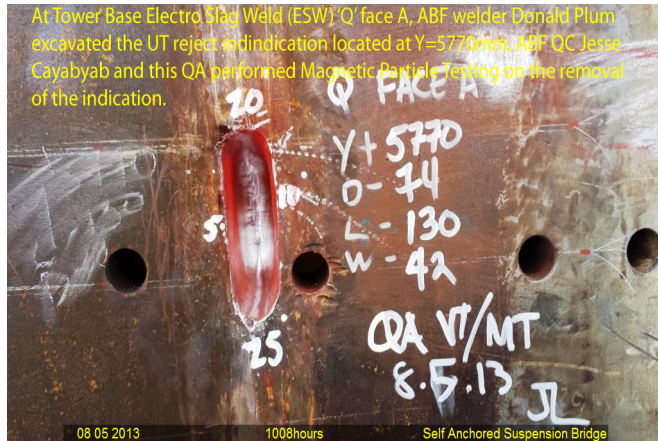
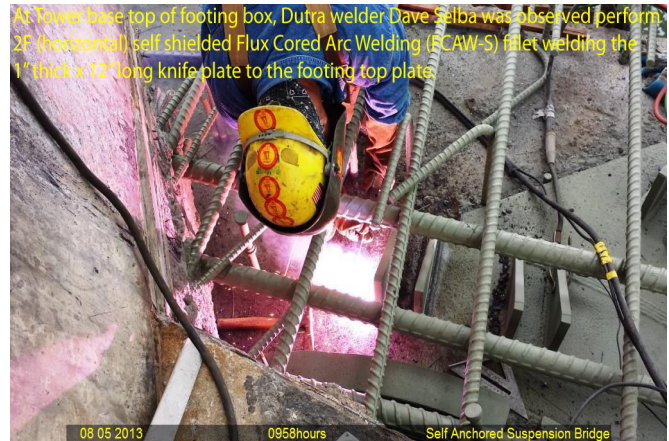
At Tower Base Electro Slag Weld (ESW) 'Q' weld joint #E-043 face A, ABF personnel was observed continuing to perform excavation on welded ESW at location Y=5770 due to UT detected rejects. The ABF personnel used the carbon air arc gouging followed by die grinder to excavate the defects. This excavation was performed per the approved Request for Weld Repair RWR#201306-002. The ABF QC personnel, Jesse Cayabyab, was noted on site monitoring the welder during the excavation. After the excavation and smooth grinding was completed, the

excavation surface was ground to a smooth and bright surface with the dimensions noted as 130mm long x 42mm wide x 74mm deep. ABF QC Jesse Cayabyab performed the visual testing (VT) and magnetic particle testing (MT) on the excavation and noted no significant defects during the test. This QA also performed the same tests verification and noted same result.

At Tower Base Electro Slag Welding (ESW) Q joint E-043 location Y=5770mm, QA randomly ABF welder Donald Plum perform 3G SMAW welding repair on the Ultrasonic Testing (UT) detected defect on the vertical weld of the ESW. The welder was observed welding in the 3G (vertical) position utilizing Shielded Metal Arc Welding (SMAW) with 1/8" diameter E7018H4R electrode implementing the welding procedure ABF-WPS-D15-1000-R03. The repair excavation and the adjacent base metal was preheated to more than 350°F using Miller Proheat 35 Induction Heating System prior/during welding. During the shift, ABF QC Jesse Cayabyab was noted monitoring the workmanship and welding parameters of the welder. The measured welding parameter during the welding was recorded at 125 amperes on a 1/8" diameter E7018H4R electrode. At the end of the shift, 3G repair welding was still continuing and should remain tomorrow.
